Audit Report „Chacaltaya“, Bolivia

Global Atmospheric Watch Station „Chacaltaya“, Bolivia

Auditor: Kay Weinhold

Date: June 24 to July 5, 2013

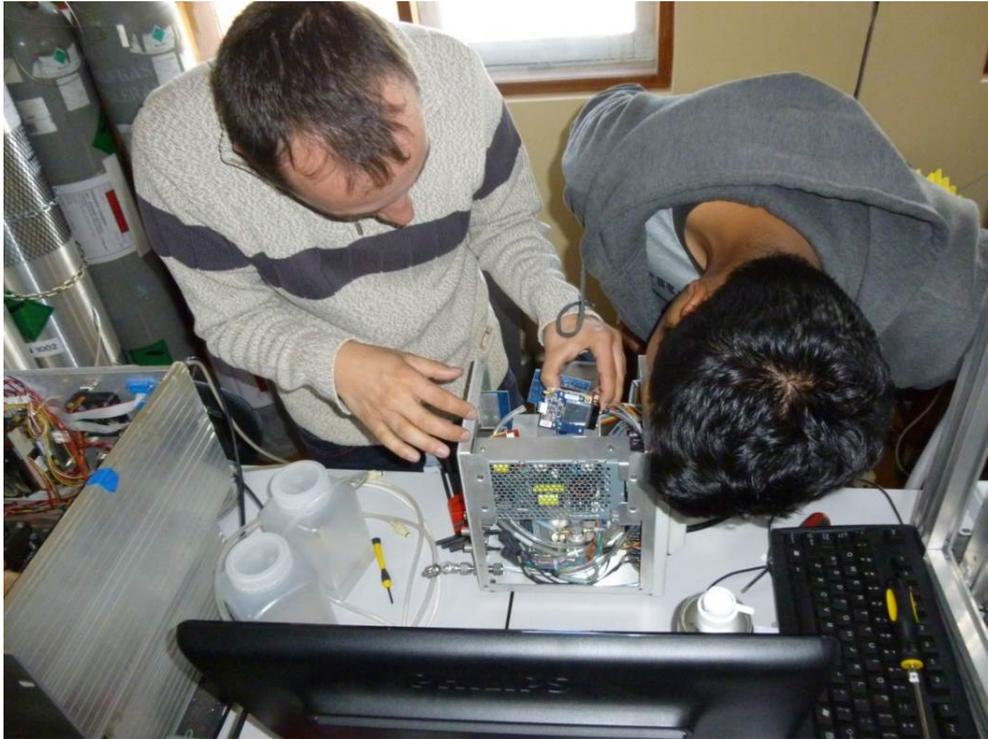
On May 31, the internal part (power supply) of the CPC 3772 from the SMPS system was burned. Until today we have no idea as to why this happened. We have never experienced this in the past. After that failure we decided via skype meeting to run the SMPS with the second total CPC 3772.

On June 25, I arrived in Bolivia and helped Fernando to check the broken CPC 3772. We found out that the power supply needs to be changed and there is no way to do this on the station since there are no spare parts available.

Figure 1: Trying to fix the problem with the total CPC 3772

We send the CPC back to europe and changed the broken parts. We did a whole CPC calibration with silver particles against a standard CPC 3772 from TROPOS and a TSI electrometer. After that, we send the CPC back to Bolivia.

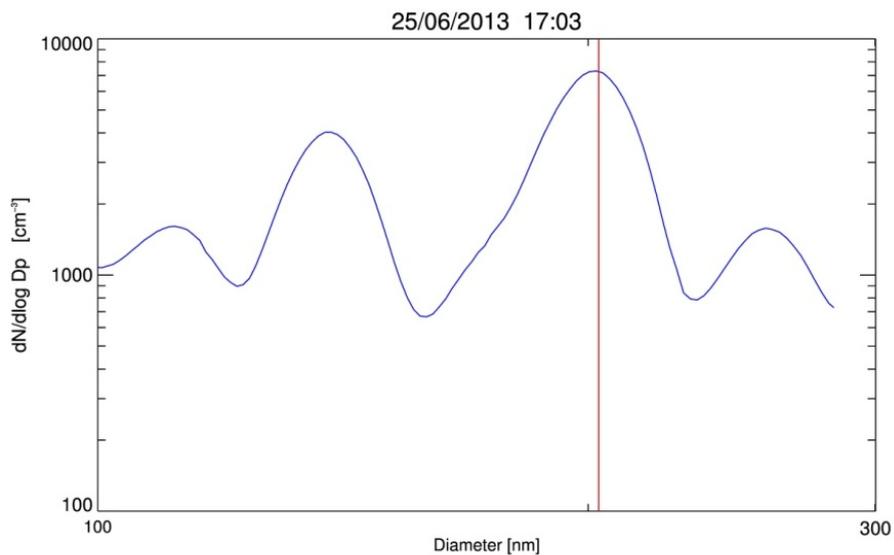
During the year, Fernando regularly did the zero, leak and latex 203 nm checks. All of them are in the range what we accept. Here is one example from June 2013. The SMPS system was working properly as it shown in figure 2.

Figure 2: LATEX test made on June 2013 at Chacaltaya station.

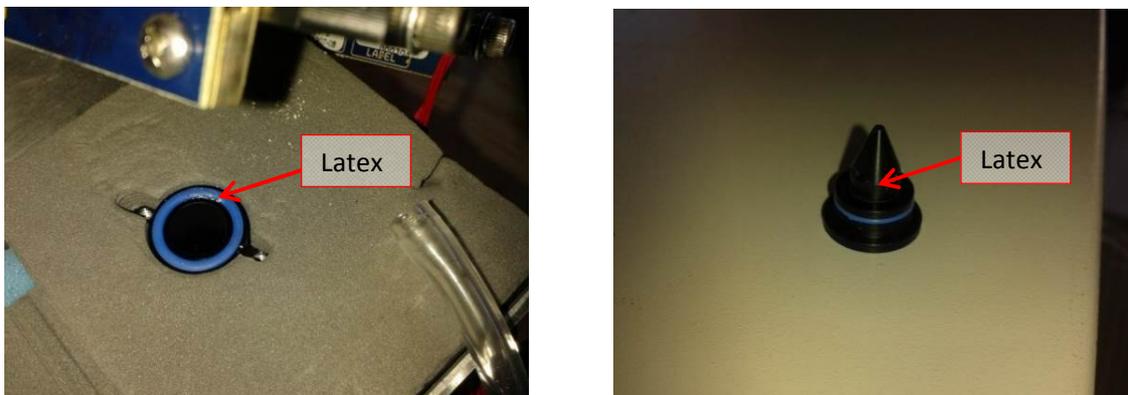
Incoming status of the system: The SMPS Chacaltaya was running without the nafion-dryer in the aerosol inlet. In the past we had problems with the old one. Because of that it was necessary to change the dryer. The second point is the total CPC 3772 was not working. We tried to reactivate the CPC 3772 on the station but we found out that the high voltage power supply was broken. It was necessary to ship the CPC back to Germany for repair. Important: After the CPC was broken they took the CPC out of the system and forgot to close the inlet. From this day until now we sucked a mix sample between ambient and lab air! We cleaned also the CPC 3772 in the SMPS. We found a lot of Latex-particles in the optical nozzle. After the whole cleaning, the CPC worked very well.

Figure 3: CPC 3772 from SMPS Chacaltaya: Picture of the cleaning.

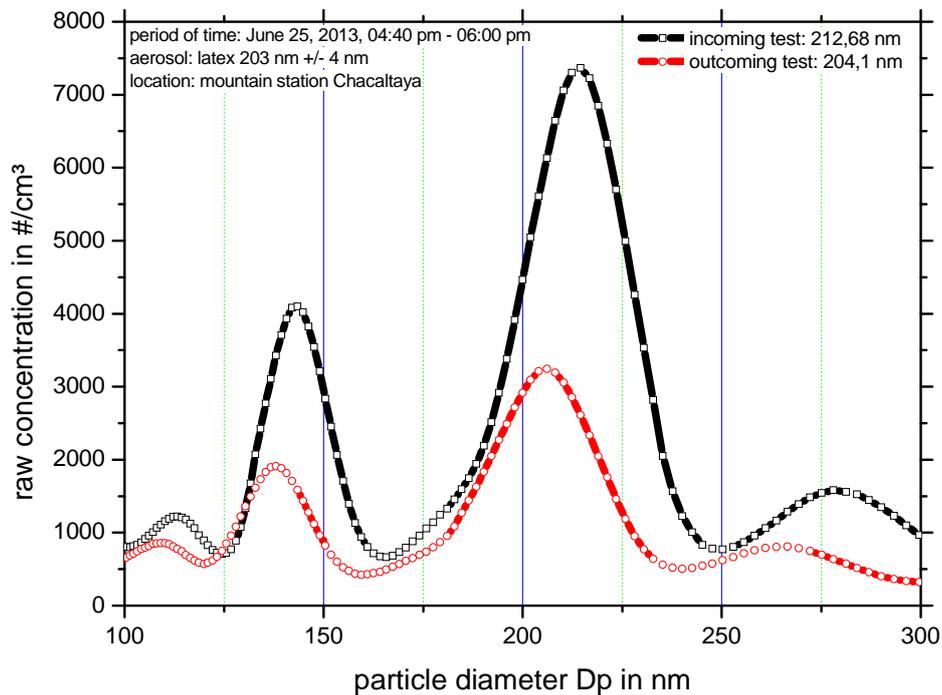
- PSL -> Latex 203 nm +/- 4 nm
 - start: 04:40 pm -> end: 06:00 pm
 - Information: from December 2012 to today the system was calibrated with the older Latex.
 - run with the old latex -> 212.68 nm
 - run with the new latex -> 212.68 nm (3.6 sheath slope)
 - run latex after change sheath slope to 3.7 -> 208 nm
 - run latex after change sheath slope to 3.8 -> 204.1 nm

Figure 2: PSL 203 nm Latex for SMPS Chancaltaya: Particle size distribution (raw concentration) for latex 203 nm on June 25, 2013 between 04:40 pm and 06:00 pm.

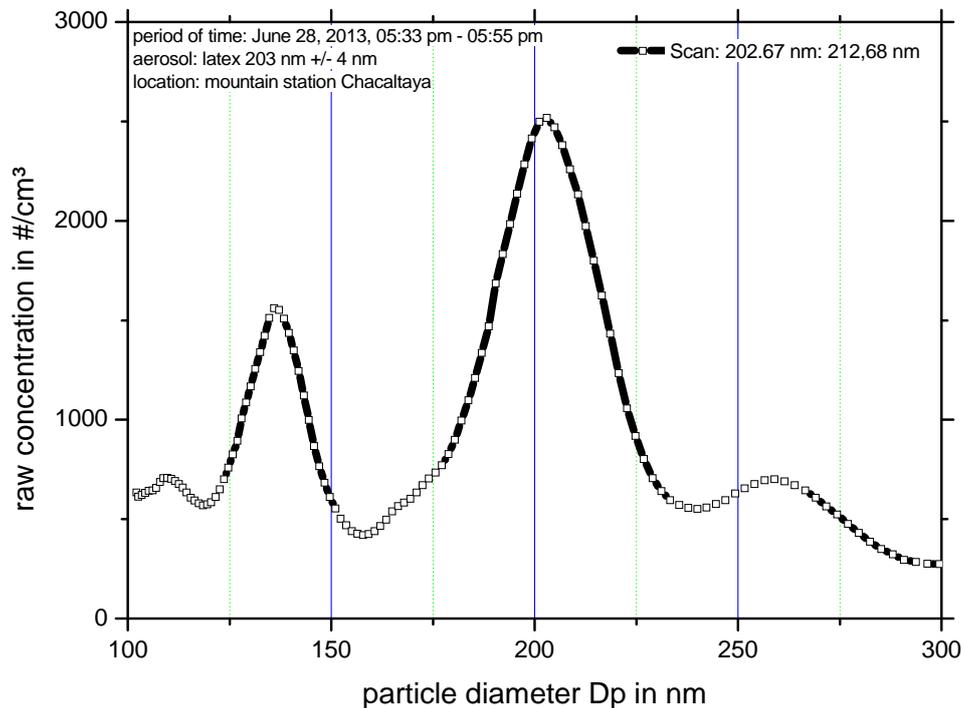
- The system was stopped at 02:50 pm
- new nafion dryer was installed
- zero-check:
 - start: June 28, 2013; 04:02 pm
 - end: June 28, 2013; 04:15 pm
 - info: 0 pp/cm³ -> o.k.
- PSL -> Latex 203 nm +/- 4 nm
 - start: 05:33 pm
 - end: 05:55 pm
 - info: 203 nm -> ok (sheath slope 3.9)

Fig.3. PSL 203 nm Latex for SMPS Chancaltaya: Particle size distribution (raw concentration) for latex 203 nm on June 28, 2013 between 05:33 pm and 05:55 pm. The pick is at 202.67 nm.
