Twinning report Danum Valley 2014, Malaysia

Global station in WMO RA II
Dr. Thomas Tuch, WCCAP

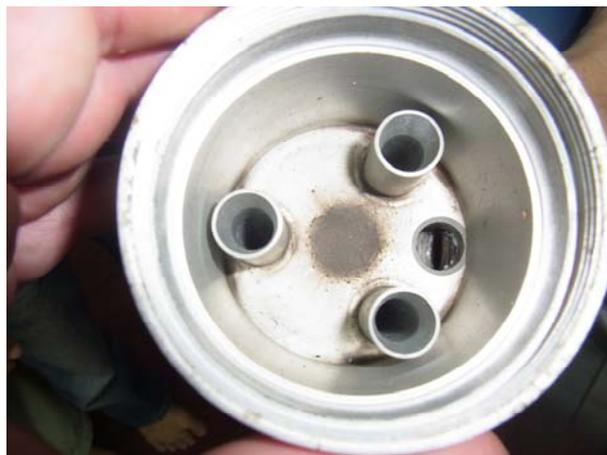
A zero check of the inlet with an absolute filter mounted provided a reasonably good zero value indicating that the inlet system was working properly. We cleaned the PM10 inlet head with the new station staff to provide the necessary training.

Figure 1: Deposits in the PM10 inlet

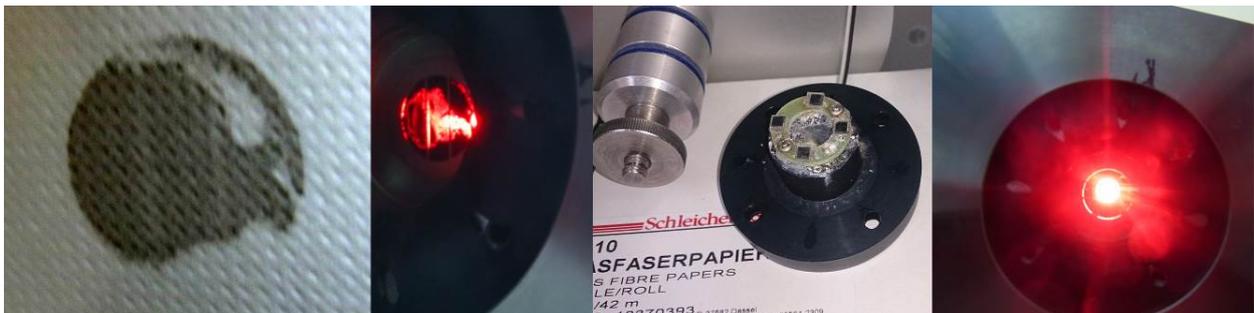
The MAAP spot looked unusual upon arrival. Parts of the normally circular spot on the filter had not been loaded with aerosol (figure 2). We dismantle the sensor and found that debris from the filterband had clogged parts of the deposition area on the filter. Furthermore the instrument must have been flooded at some time because all sensors used for transmission measurements were dirty. After cleaning the illumination area with compressed air and wiping the sensors first with distilled water and then ethanol the performance of the instrument increased significantly.

Figure 2: (left to right) MAAP spot prior to cleaning, MAAP illumination prior to cleaning, dirty sensors, MAAP illumination after cleaning.

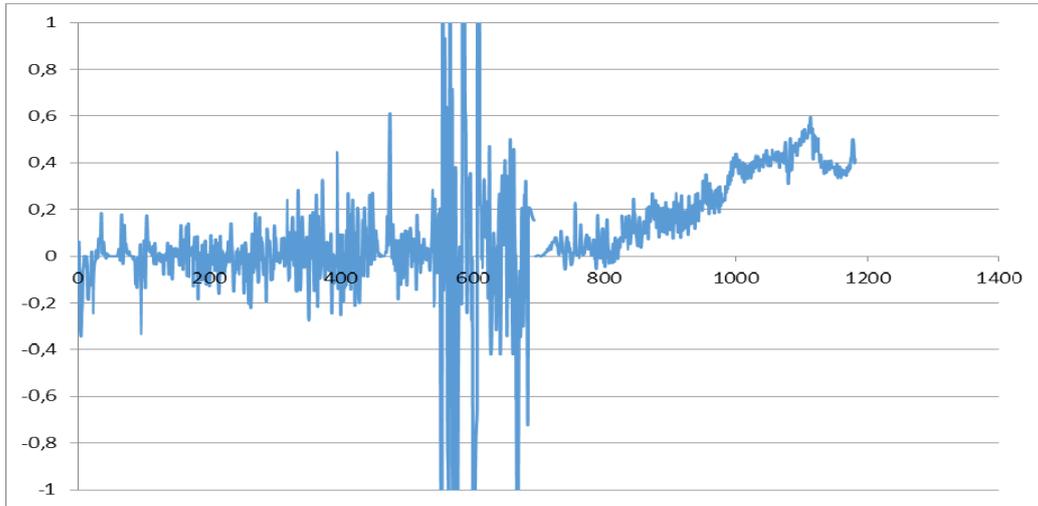
Change of MAAP performance prior to and after cleaning is shown in figure 3: Note that the illumination is probably the most significant reason for the improved performance of the instrument. As the influence of non-even filter spots in the MAAP has never been investigated MAAP results need to be considered questionable.

Figure 3: Change of MAAP signal prior to (~700) and after cleaning, One minute data.

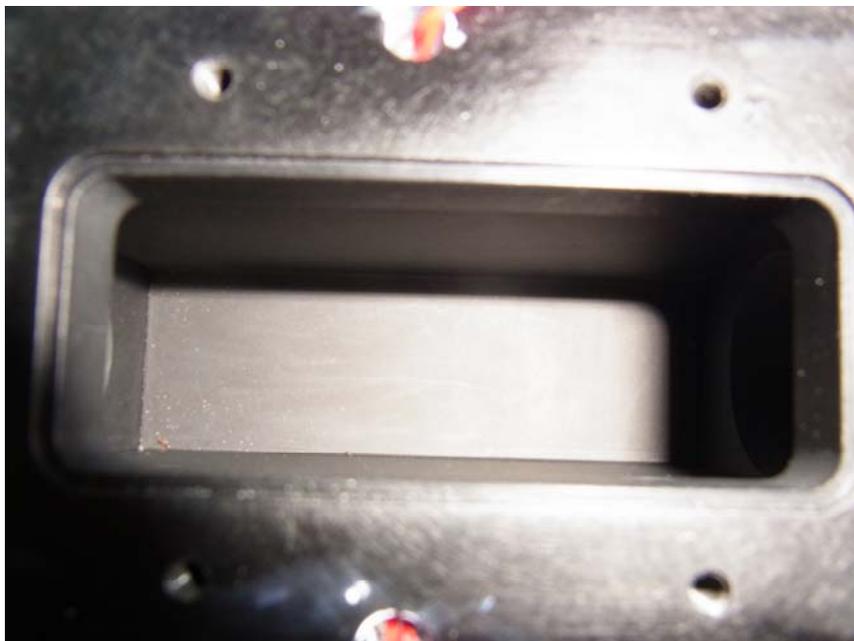
The Nephelometer at the station has been properly calibrated and maintained during the two years since we visited the station. Because the new station staff has never been trained on the maintenance of Nephelometers we decided to clean the measurement cell – which was necessary according to figure 4.

Figure 4: Nephelometer measurement cell prior to cleaning,

20.05.2014 05:31 get new backup batteries from Infrapro
20.05.2014 06:26 reassemble Neph
20.05.2014 06:27 on startup backscatter is negative see picture -> cleaning was necessary

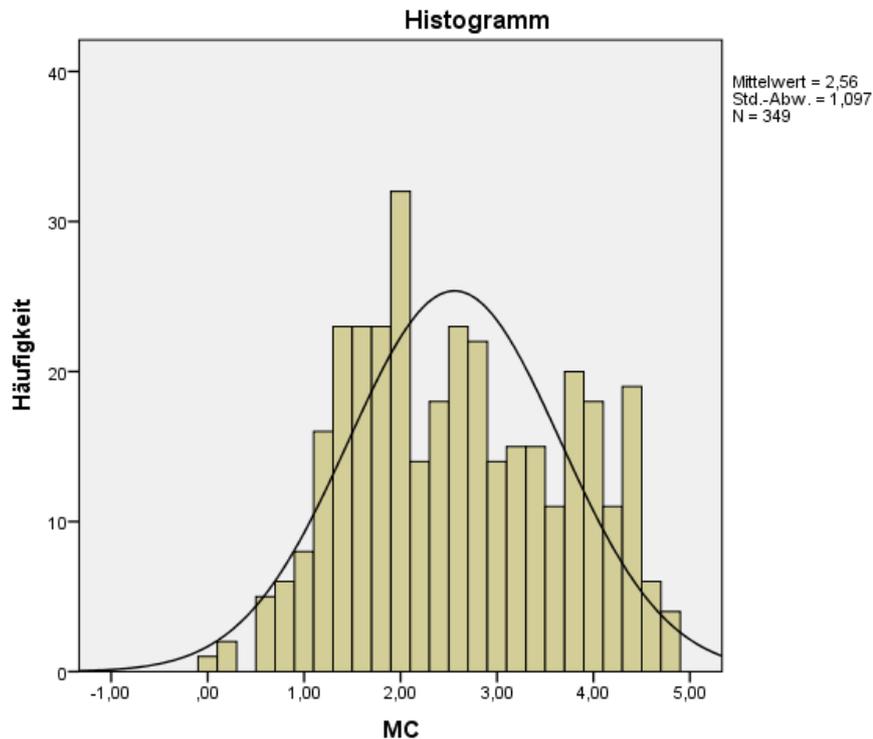
TEOM:

22.05.2014 02:48 Logbook started
22.05.2014 02:48 DAQ PC stopped 4 am due to windows update
22.05.2014 02:48 local time 8:48
22.05.2014 02:50 TEOM is still 2.56 with zero filter

22.05.2014 02:50 need to solve the TEOM problem
22.05.2014 02:50 need urgently to solve the PC Windows problem
22.05.2014 03:07 TEOM offset is constant
22.05.2014 03:08 connect TEOM to main inlet
