Site audit report Mauna Loa, Hawaii

World Calibration Centre for Aerosol Physics, Leipzig, Germany

Summary: Measurements of physical aerosol properties at the global GAW station Mauna Loa (MLO) were audited by Prof. A. Wiedensohler and Dr. Thomas Tuch and of the WWCAP on December 3rd 2007. Mauna Loa Observatory is located on the Island of Hawaii at an elevation of 3397 m on the northern slope of Mauna Loa volcano (19.539°N 155.578°W, fig. 1). The station has been established 1957.

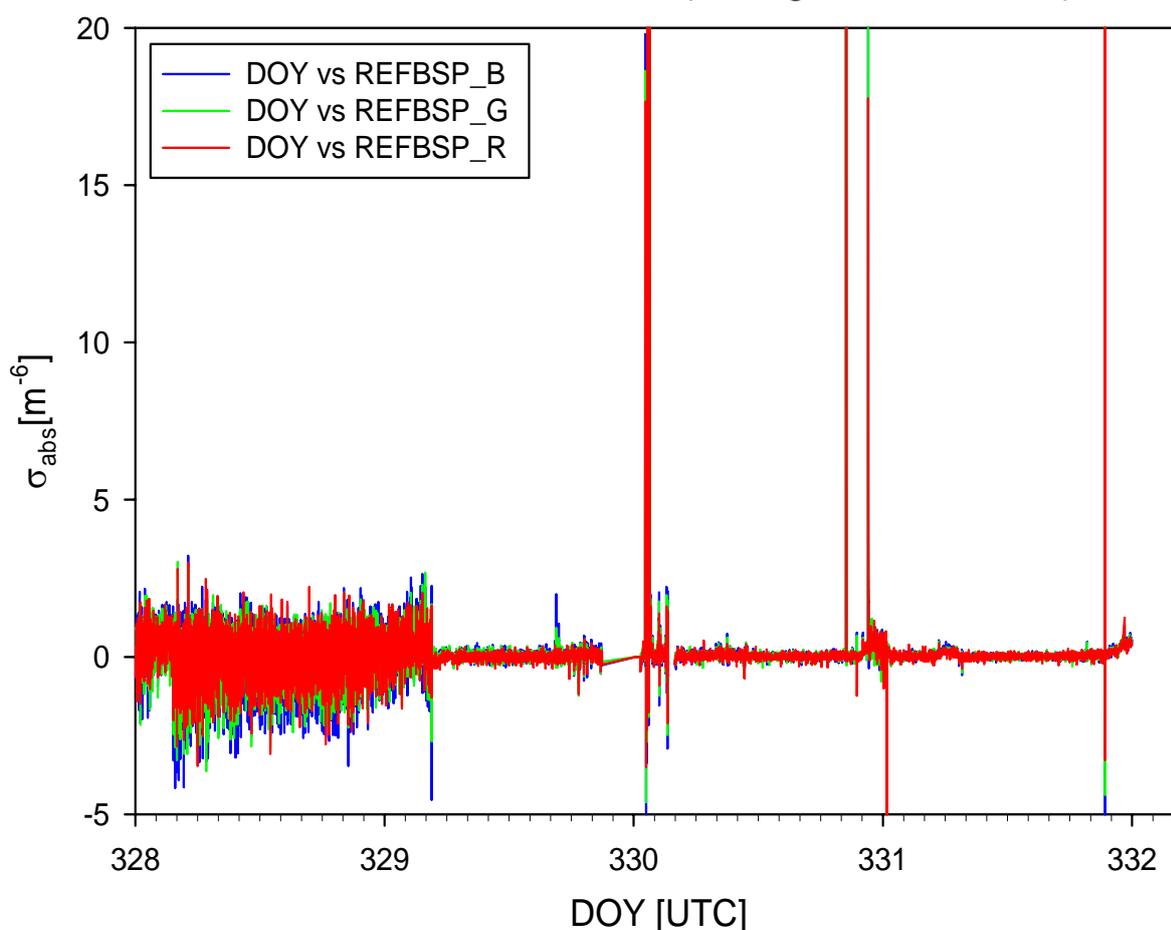
Figure 2: Absorption coefficients prior to the audit of MLO (1minute data), DOY 328 = 24.11.2007

Absorption Coefficients: A three wavelength PSAP S/N 107 is available at the site. A time series plot of the absorption coefficients during the audit is shown in fig. 2. Note that the elevated noise of the instrument prior to day 329 is probably due to the reduced flow rate of 0.16 l/min. This problem emphasizes the need of more frequent flow calibrations. It would have helped the site technician to identify this problem.

The PSAP at MLO is in good condition.

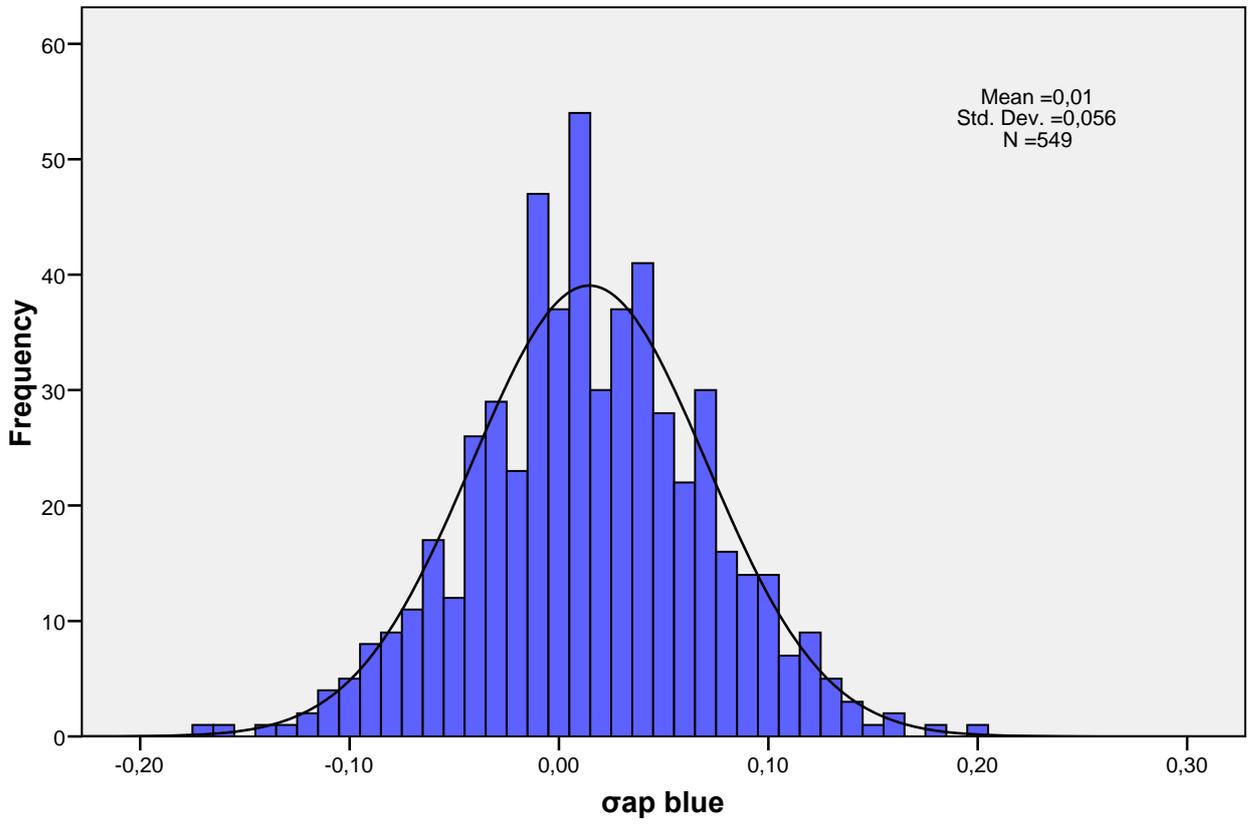
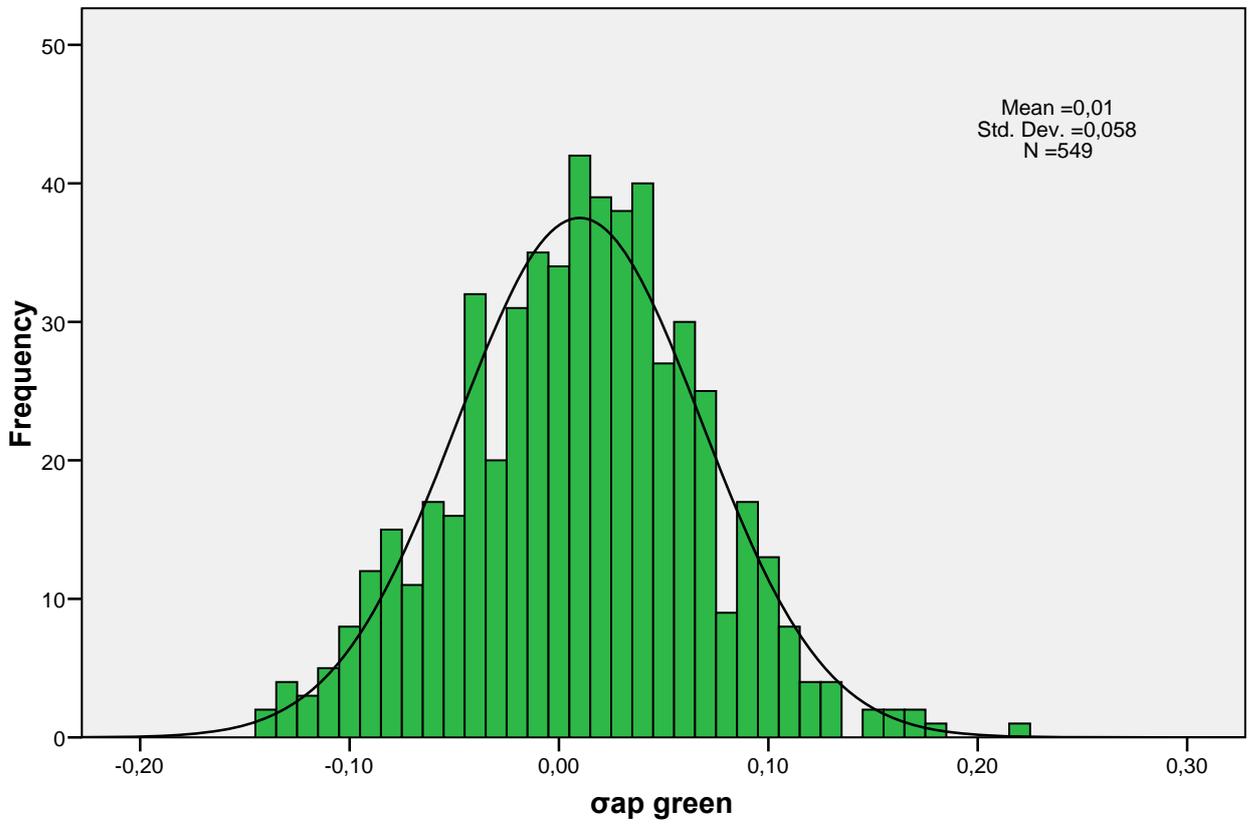
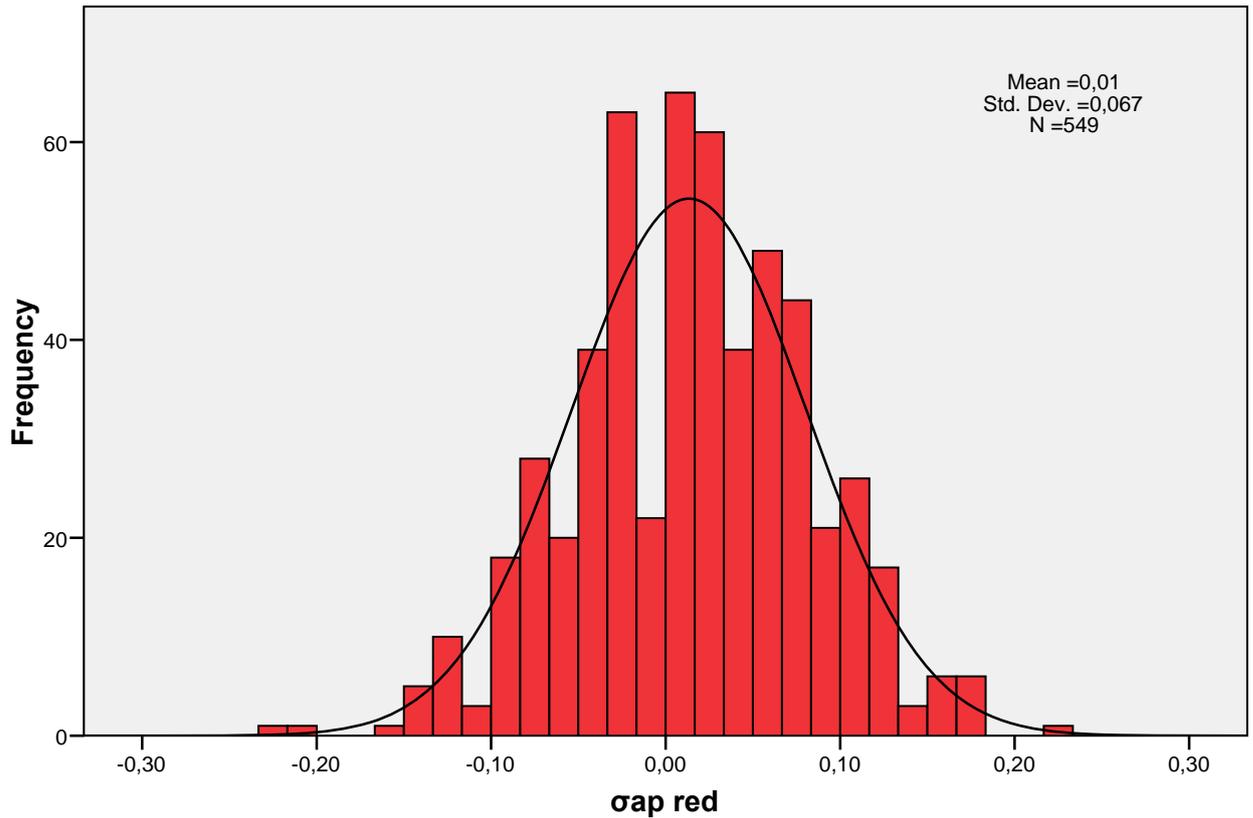
Fig.3: Frequency distribution of zero measurements of the PSAP at MLO

Figure 3 shows the frequency distribution of 1 minute absorption coefficients for all three wavelengths during the zero filter measurements.

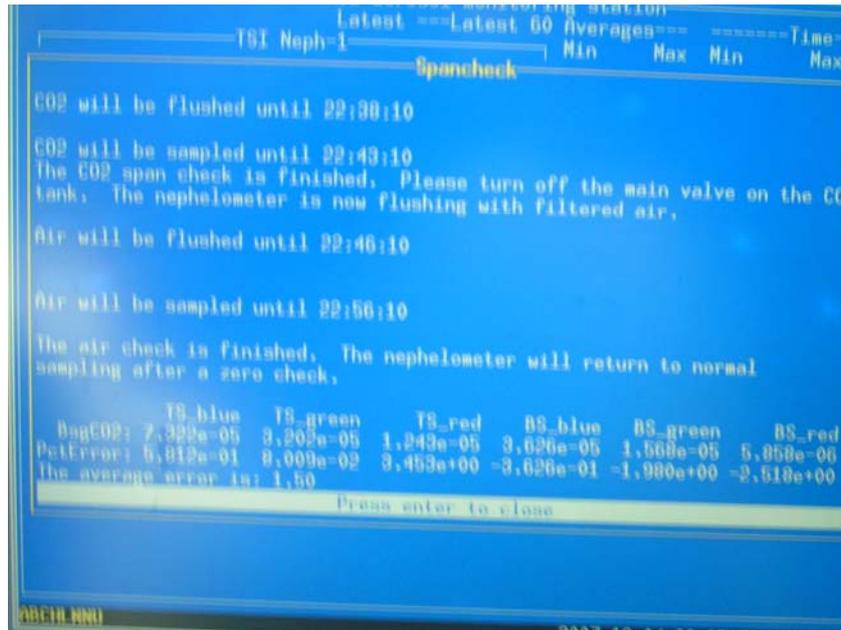
Figure 4: Span check of MLO Nephelometer

A span check of the Nephelometers was performed during the audit. The average deviation from the last calibration was 1.5%. (Fig. 4). Typical average span check deviations are shown in figure 5.

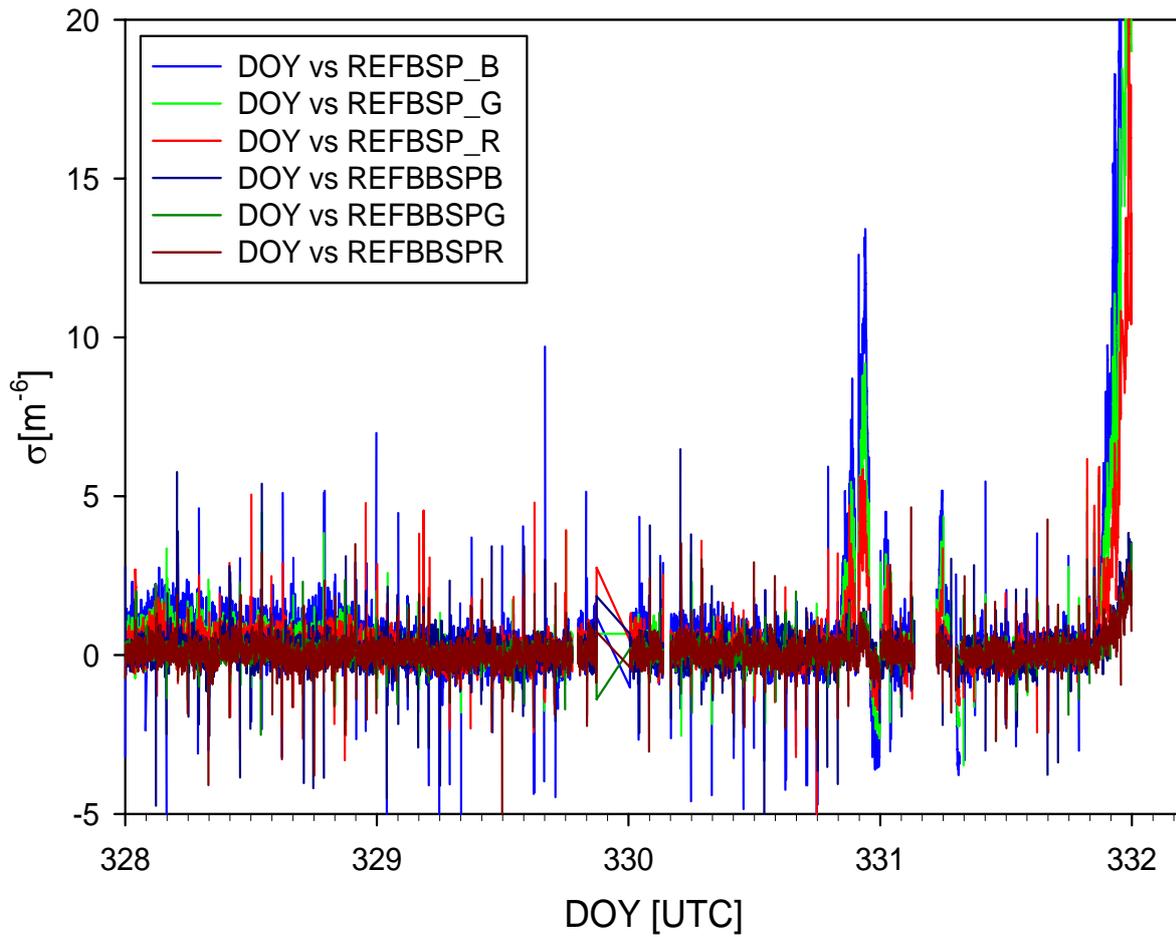
Figure 6: Time series of 1 minute Nephelometer data during the routine maintenance prior to the audit.

The time series of scattering and backscattering coefficients during routine maintenance prior to the audit is shown in figure 6.

Statistical Parameters during the zero measurements prior to the audit are summarized in table 4. Note that mean values of the zero measurements are in the range of real scattering coefficients which may occur during measurements under clean air conditions at MLO.

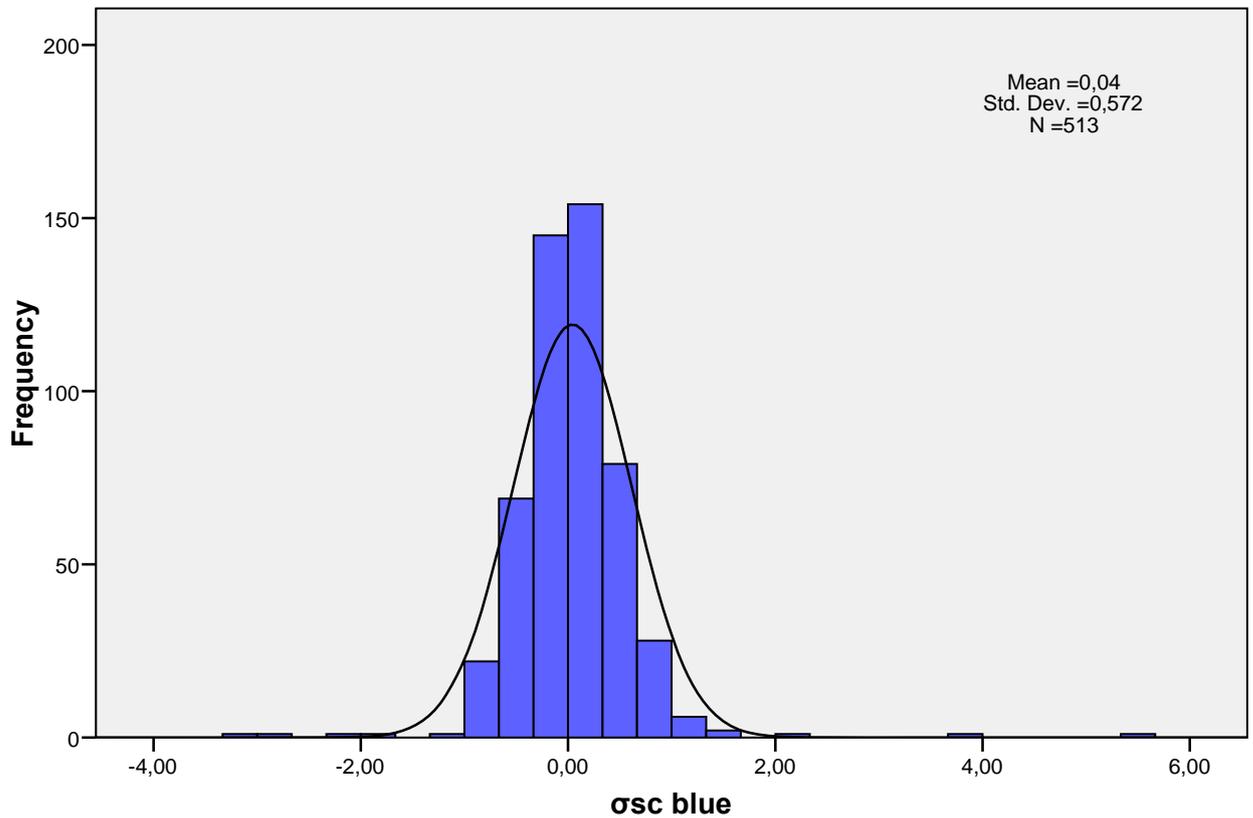
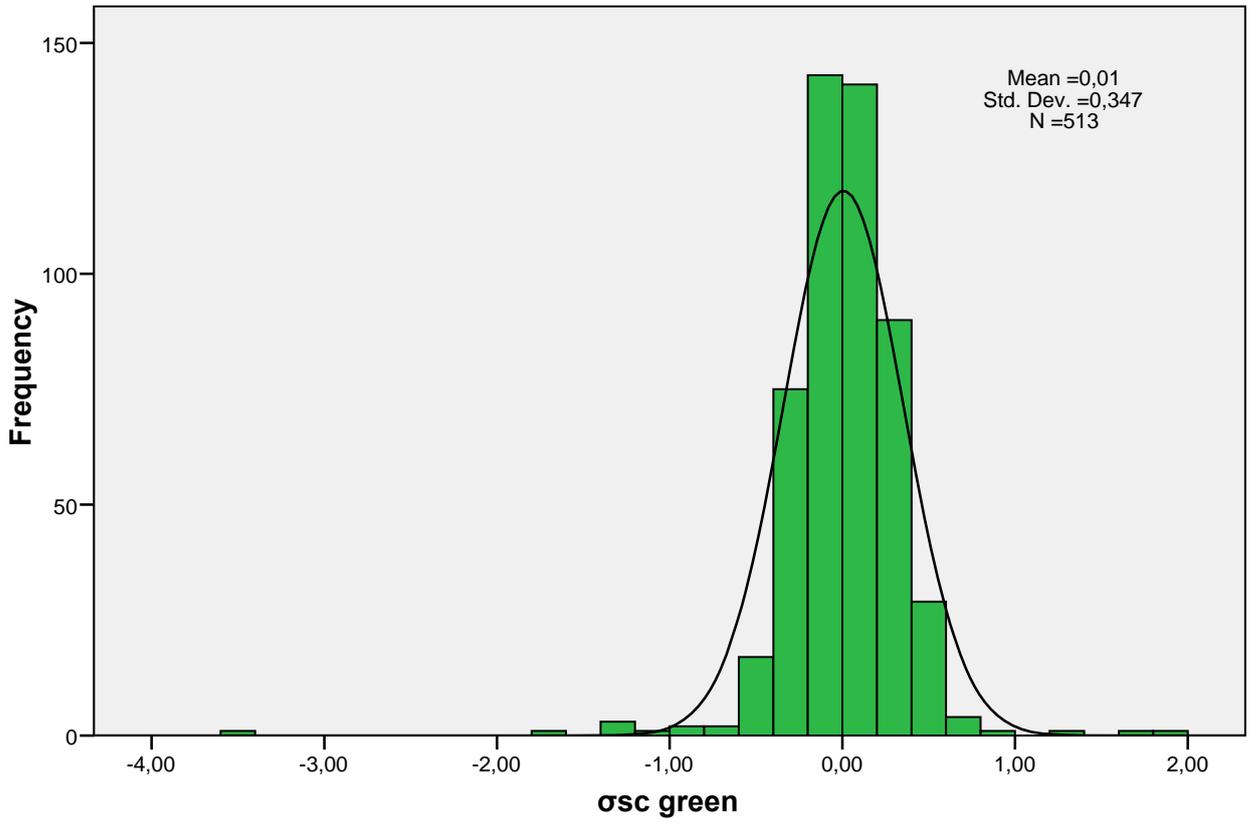
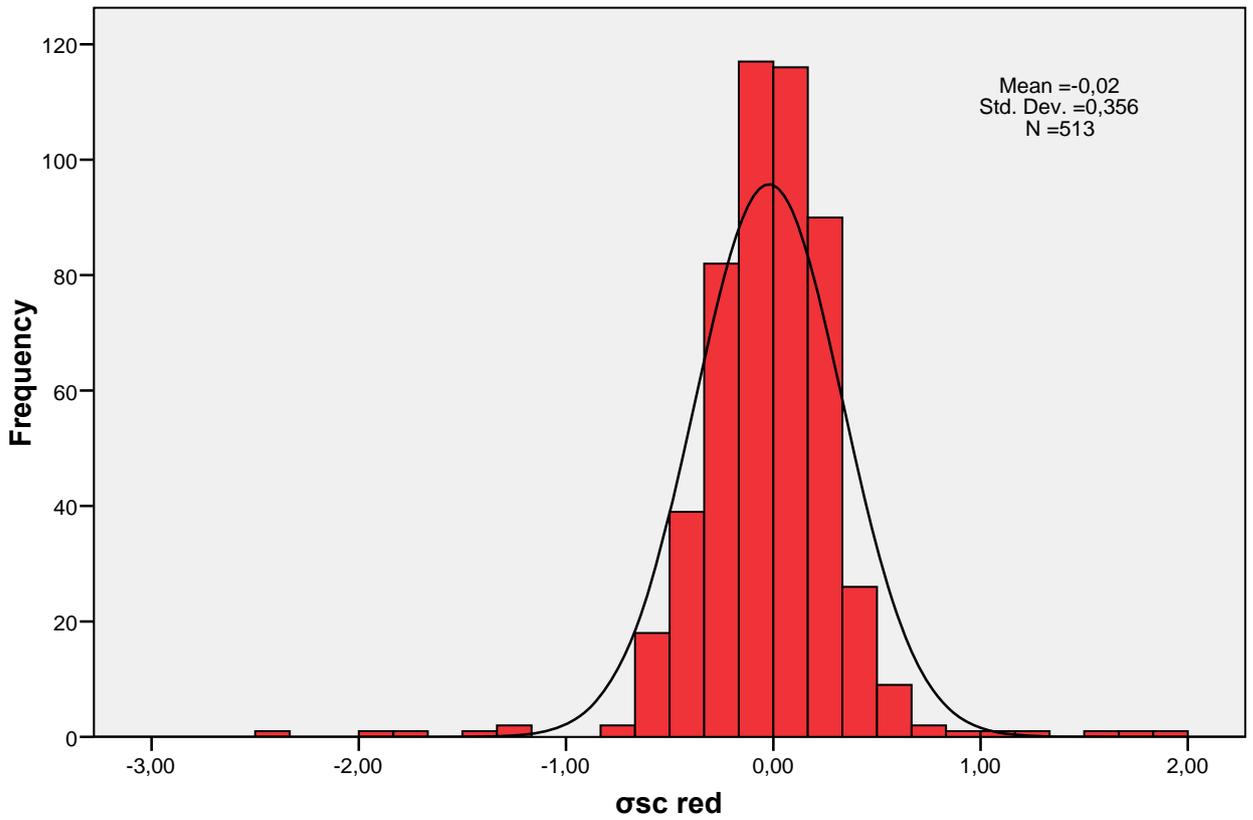
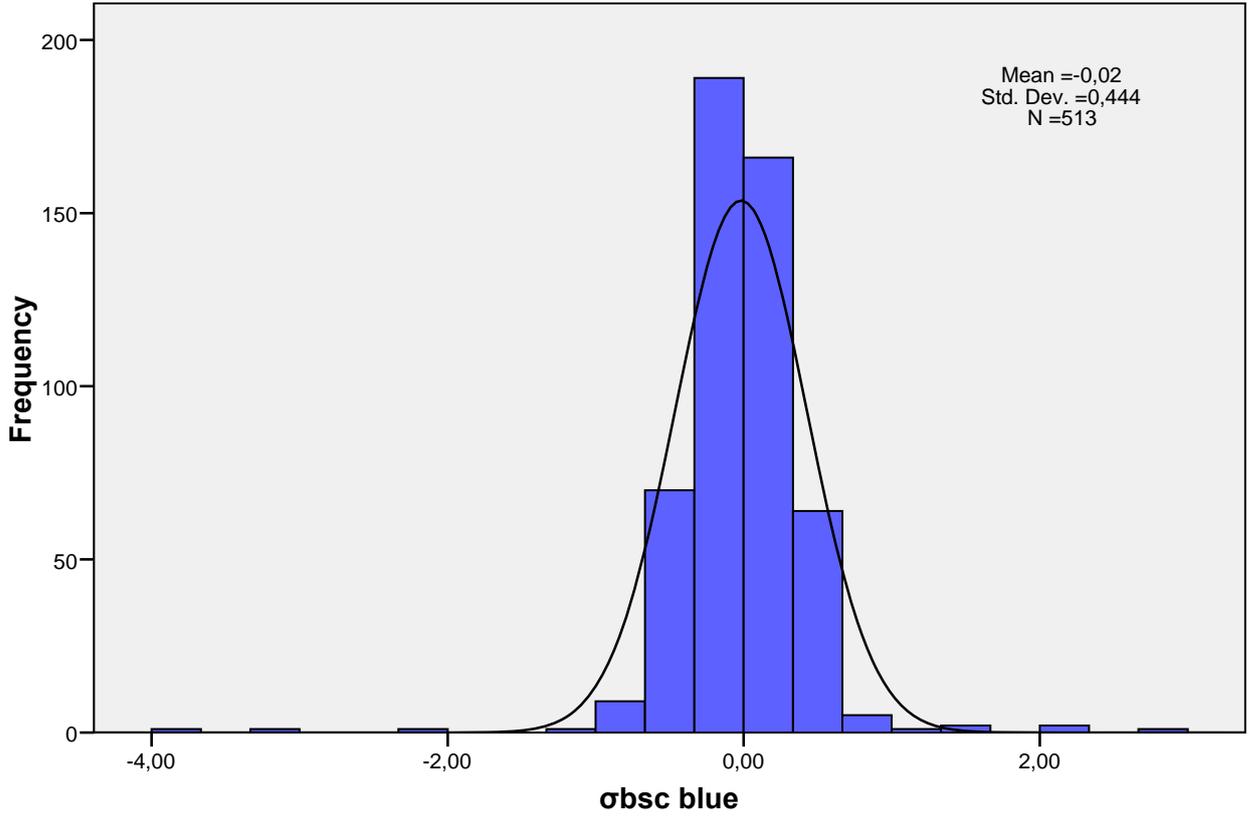
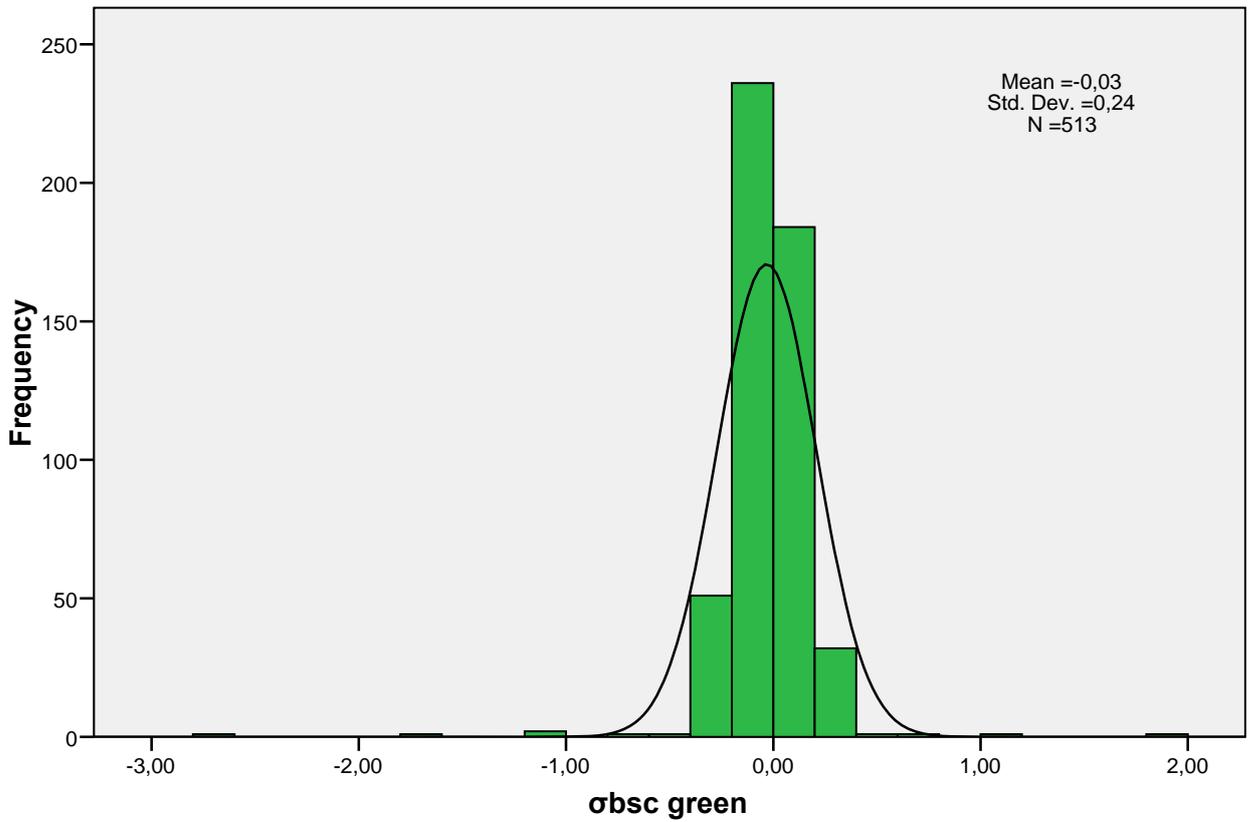
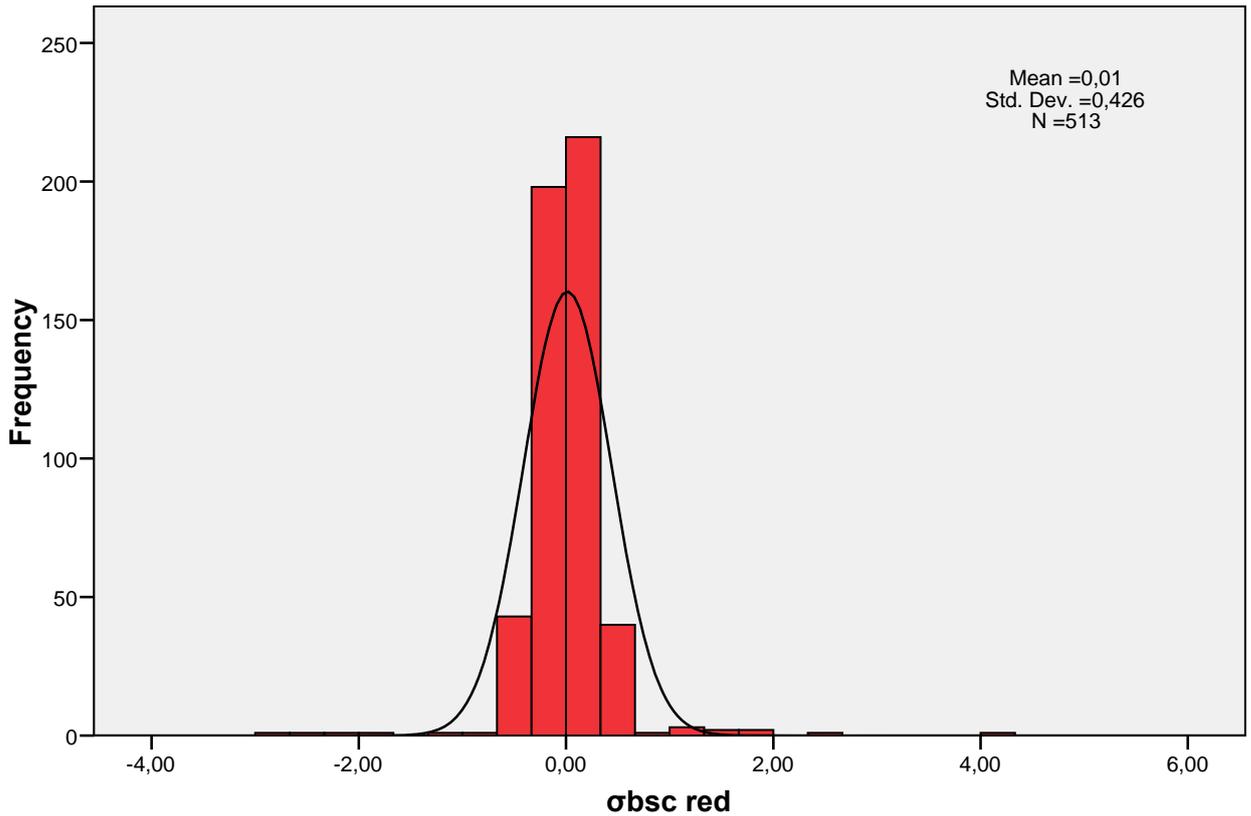
Figure 7: Noise check (with absolute filter) of the TSI Nephelometer, 1 minute data

Figure 7 summarizes the results of the noise check of the Nephelometer prior to the audit. Instrument noise for this instrument is in the typical range for TSI Nephelometers.

The Nephelometer at MLO is in good condition

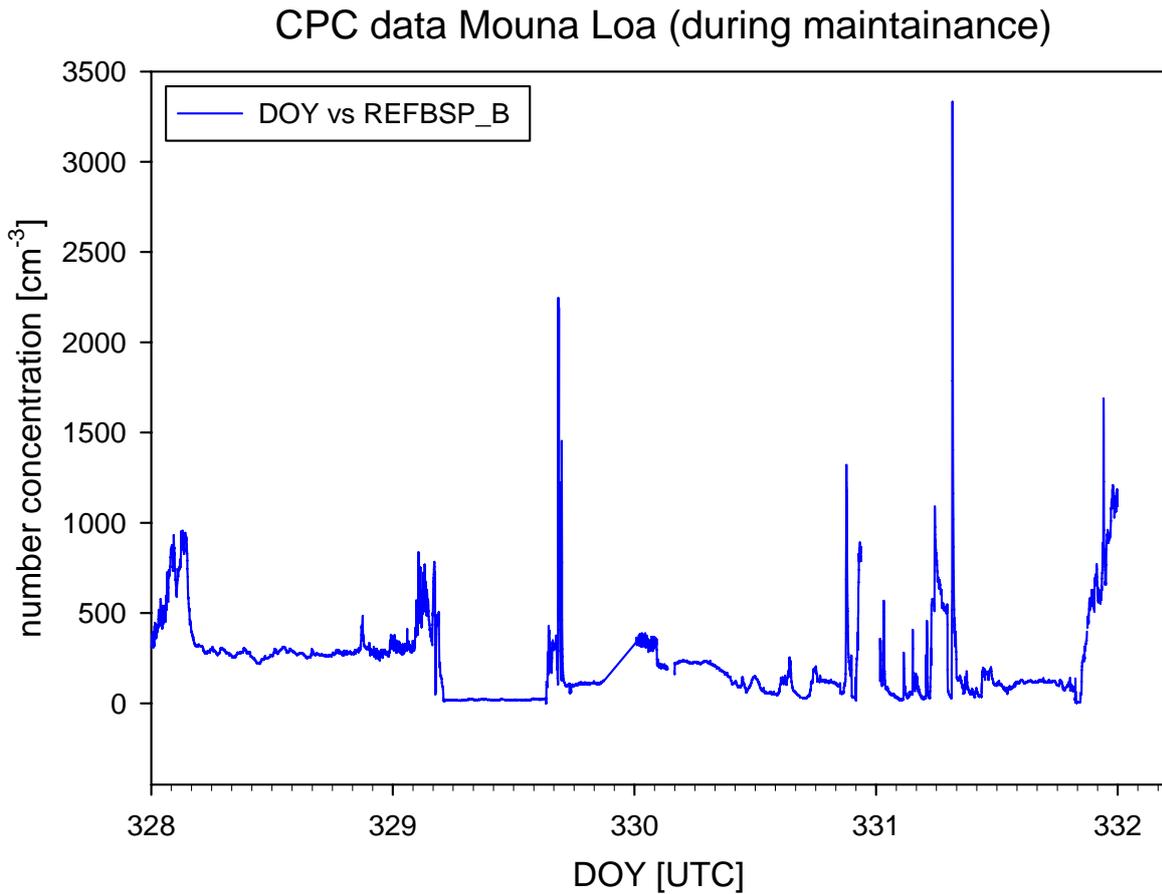
Fig. 8: Time series of CPC and CCN measurements prior to the audit at MLO

The problem with the elevated count rate was persistent during our audit. We found out, that the count rate of the CPC increases with increased pressure drop at the inlet of the instrument suggesting a leak in the instrument itself. Although the instrument is only used to identify local pollution this instrument needs to be fixed as soon as possible.

The CPC at MLO was not working according to specifications

The CPC has been exchanged after the audit
