Site audit report Birkenes, Norway

Dr. Thomas Tuch, WCCAP

World Calibration Centre for Aerosol Physics (WCCAP),
Leibniz Institute for Tropospheric Research, Leipzig, Germany

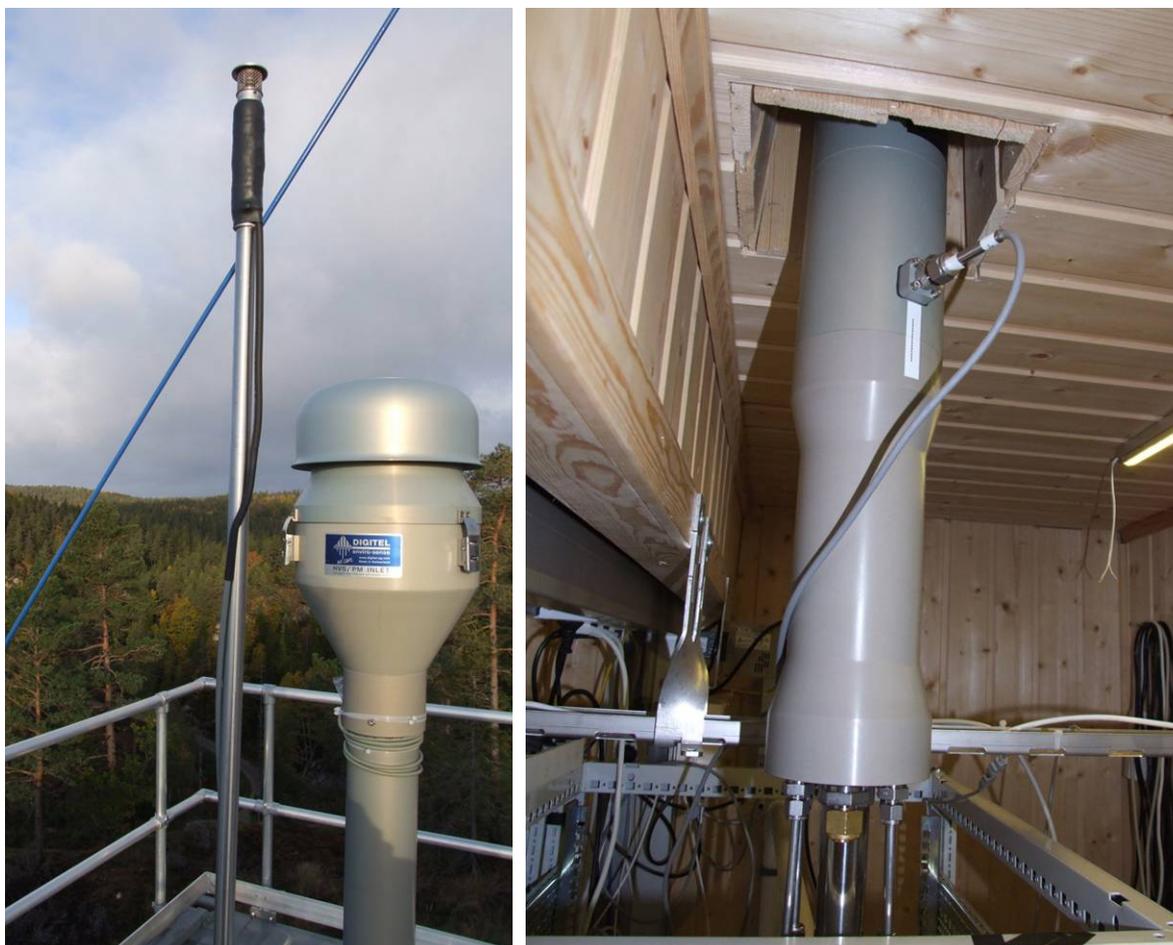
Figure 4: Aerosol inlets at Birkenes.

Two aerosol inlets are used at Birkenes. The left one in figure 4 is a whole air inlet for the Grimm OPC. The right one is a custom designed heated inlet by Digitel operated at a flow rate of 140 l/min. All other aerosol instruments sample from this inlet. All aerosol lines are made of stainless steel. A Nafion dryer is used for humidity conditioning for the DMPS. Samples for the PSAP and the Nephelometer are not humidity conditioned. Heating may only be suitable to adjust aerosol rH for these instruments if the ambient temperature does not exceed the temperature of the laboratory if ambient rH exceeds 50%.

Aerosol inlets at Birkenes comply with EUSAAR requirements.
